Geotechnical Lessons Learned from Mexico and Other Recent Earthquakes

(State of the Art Paper)

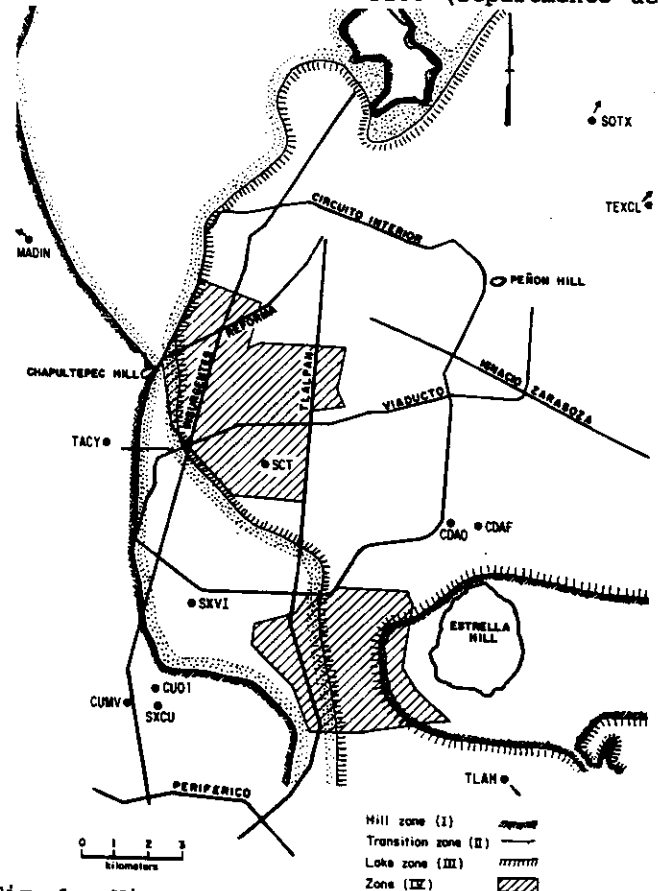
Fig 1. Microzoning adopted in Mexico City's 1987 Building Code. Circles indicate the sites where the 1985 earthquakes were recorded

What we now know about this subsoil is presented succinctly in figs 1-9. The map in fig 1 shows the microzoning adopted in the 1987 Building Code for the Federal District (Departamento del

Distrito Federal, 1987). Three zones are recognized: I rock and firm ground; II transition; III lake bed. Zone I comprises a few outcrops, the hilly areas and what has been termed firm ground, i.e. with no deformable clay deposits. In zone II, a transition where shaking has not been exceptionally violent, there are deformable clay deposits, their total thickness ranging between 0 and 20 m. In zone III the total thickness of deformable clay in the old Texcoco lake basin varies between 20 m at the old town center and 40 m at the virgin lake bed whereas in the Xochimilco-Chalco region it can exceed 100 m.

A simplified contour enclosing the areas where shaking was especially intense in 1985 as inferred from the damage distribution, shows that these fall within zones II and III (Iglesias, 1987). For seismic design, a subzone containing these areas, zone IV, is included within zone III and a small portion of zone II.

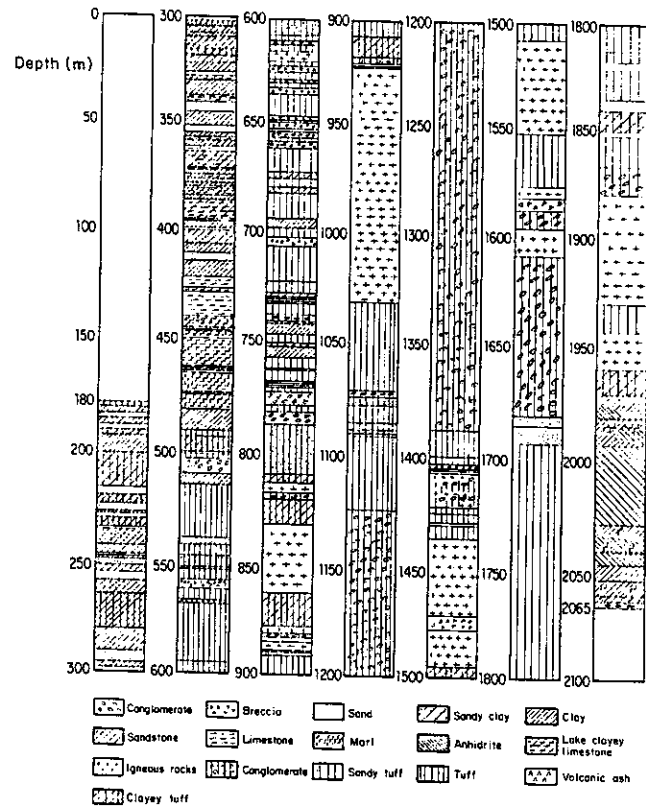
Fig 2. Profile showing the strata that underlie the compressible clay deposits in Mexico City

In zone I one typically finds up to a few hundred meters of compact, mostly granular soil or volcanic tuff followed by firm agglomerates including some lava flows and, at depths reaching more than 2000 m (fig 2) the Balsas limestones or Upper Cretaceous Formation (about 60 million years old). The firm agglomerates consist of vulcanites, first of the Cocos Formation (18 million years old) and under them the Farallón Formation, resting directly on the Balsas limestones. In zone II, on top of the harder soils there are a few meters of very deformable clay with water contents of up to 200 percent and often, on top of this, a harder crust (frequently an archaeological fill) reaching a few meters in thickness. A typical boring

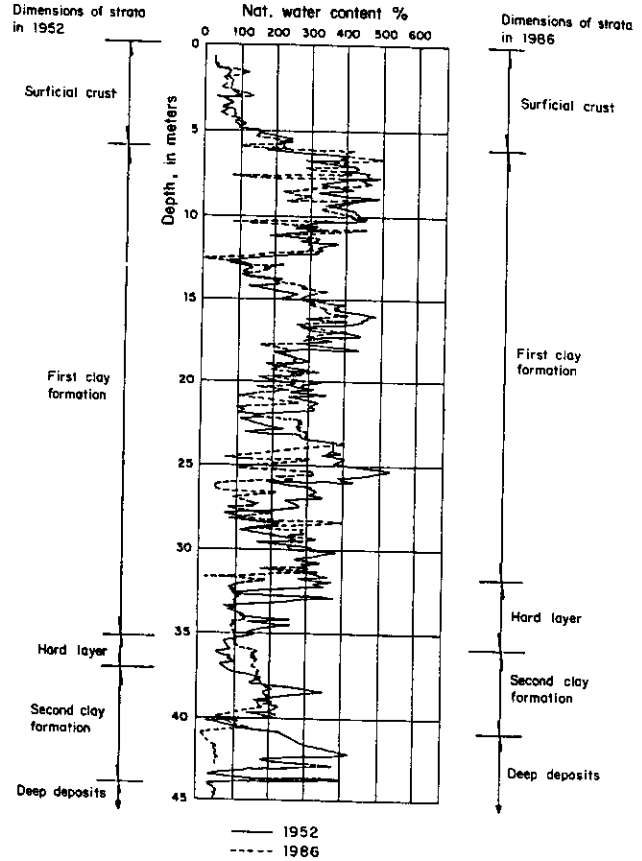
Fig 3. Natural water contents at a site in zone III (data after Marsal and Mazari, 1957 and Jaime, 1987)

in zone III (fig 3) will find a hard crust; then a first clay formation with water contents exceeding 400% and sometimes reaching 600% interspersed with thin seams of ash, sand and volcanic glass down to perhaps 30 m from the surface; next the "first hard layer," an agglomerate having 1-3 m in thickness and very variable hardness, often difficult to penetrate with concrete piles unless there has been previous perforation; under this there is a second clay formation, similar to that in the transition zone; at about 50 m from the surface one meets the second hard layer; from there on down, things are much as under zone II, save

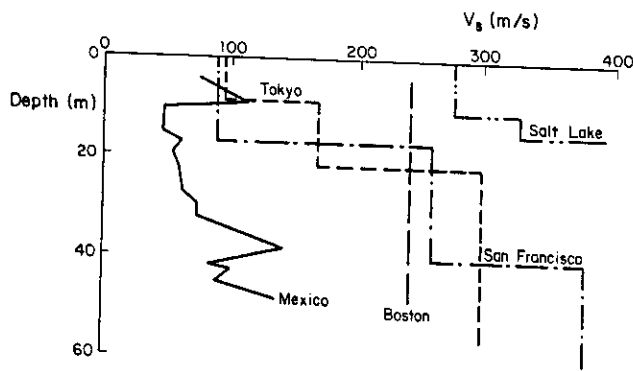
Fig 4. Shear wave velocity profiles in Mexico City and other locations (after Whitman, 1986)

Shear wave velocities in the soft clay have been obtained through field and laboratory tests. Typical average values (75 m/s in the upper formation and 110 m/s in the lower one) are low compared with those obtained on less plastic clays (fig 4). Somewhat smaller values are found in the South of the city. Shear wave velocities

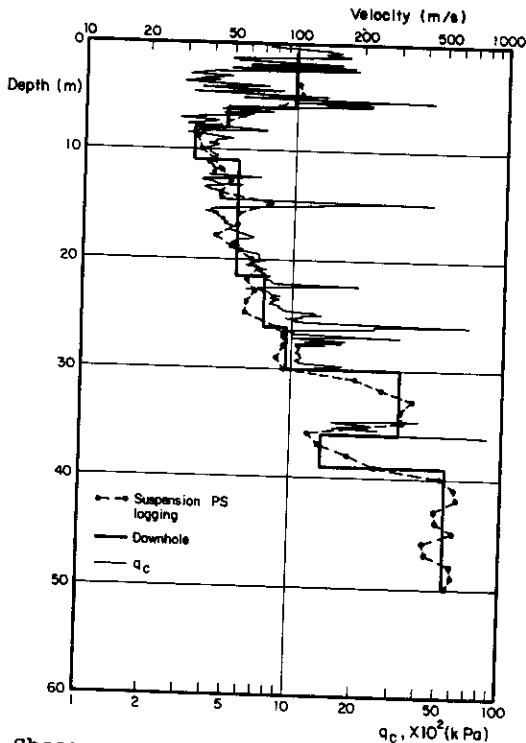
Fig 5. Shear wave velocity and cone penetration resistance. Preloaded Texcoco Lake, zone III (after Jaime and Romo, 1988)

in other formations are also shown in figs 5 and 6.

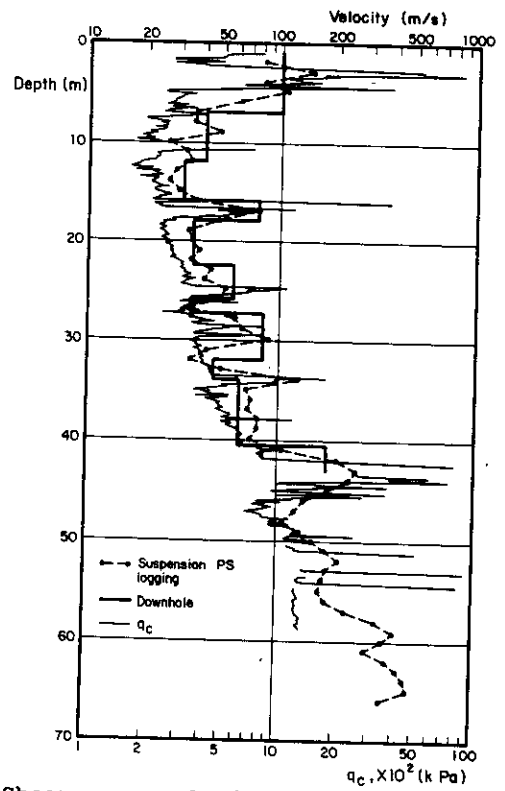
Fig 6. Shear wave velocity and cone penetration resistance. Virgin Texcoco Lake, zone III (after Jaime and Romo, 1988)

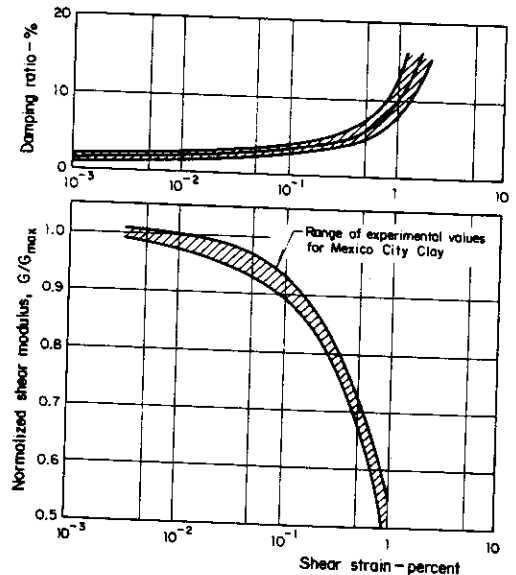
Fig 7. Damping ratio and normalized shear modulus versus strain for Mexico City clay (after Seed et al, 1988)

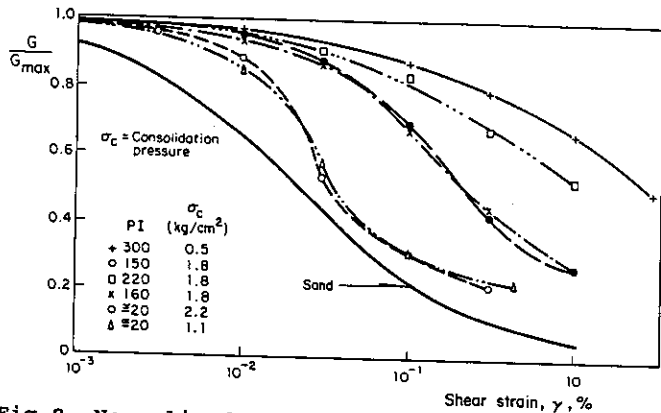
Fig 8. Normalized shear moduli versus strain for soils having different plasticities (after Romo et al, 1989)

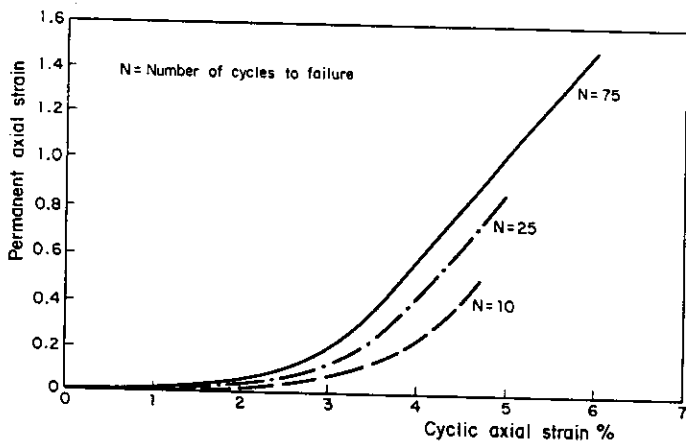
Fig 9. Permanent strain accumulation during cyclic triaxial tests on Mexico City clay (after Romo et al, 1989)

threshold shear strain, typically 3%, below which the cyclic stress-strain behavior is essentially elastic (fig 9). Furthermore, Mexico City clay, when tested under dynamic conditions, can exceed its static strength by as much as 20% (Romo et al, 1989b). Rate effects may account for this, according to data from CU triaxial tests (Alberro, 1979). The soil is markedly thixotropic, reducing its strength to the order of 1/30 upon remolding. Laboratory data show that after a short time it regains most of its original strength (Jaime, 1987; Legorreta, 1988).

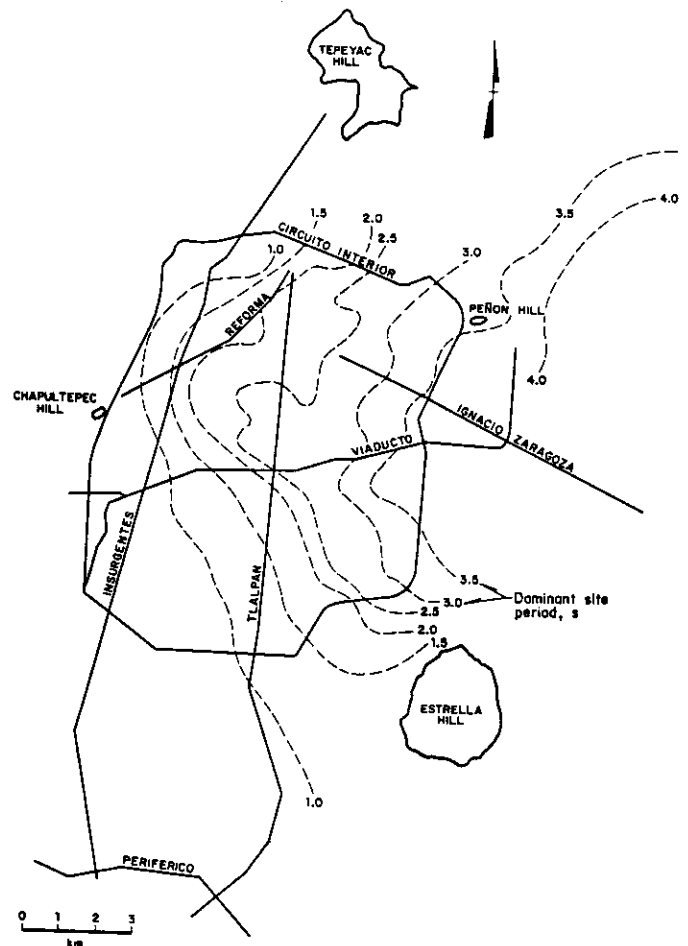
Fig 10. Dominant period contours in Mexico City (after Lermo et al, 1988)

the site, that is, the period at which the peak spectral acceleration occurs during earthquakes sufficiently small so as not to cause widespread nonlinear behavior of the soil. Values found for these prevailing periods are shown in fig 10.

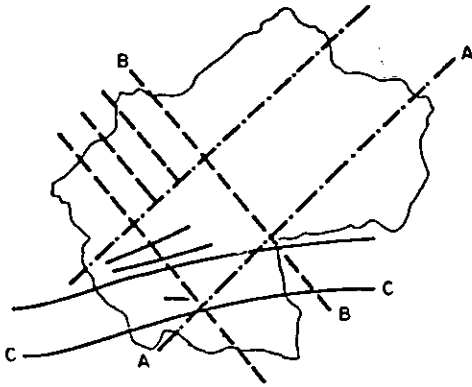
Fig 11. The Valley of Mexico and its fault systems (after Mooser and Montiel, 1990)

The Upper Cretaceous is traversed by three systems of faults under and around the valley (fig 11). One such system runs approximately NW to SE; distributed over five nearly vertical faults along a few hundred kilometers, this system could respond to a total vertical offset of around 1500 m; it may constitute one end of a graben. The other two systems—Tlaloc-Apan and Santa Catarina—run at about 45° with the directions of the cardinal points. They have in all likelihood been caused by shearing stresses and ensuing strike-slip, induced by the EW component of relative motion between the oceanic Cocos Plate and the North American Plate. This component has changed in rate and sign over the 25-million-year history of the Cocos Plate.

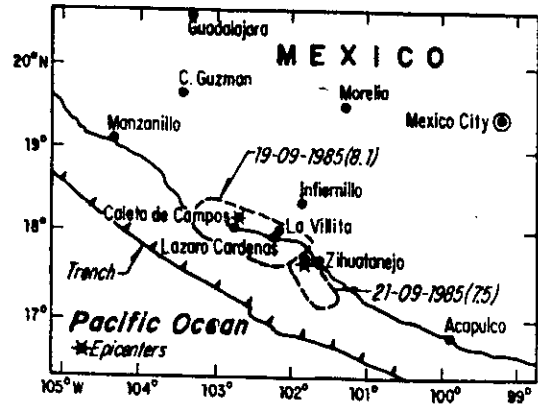
Fig 12. Epicenter for the September, 1985 earthquakes and areas of rupture in the subduction zone (after Meli and Ávila 1989)

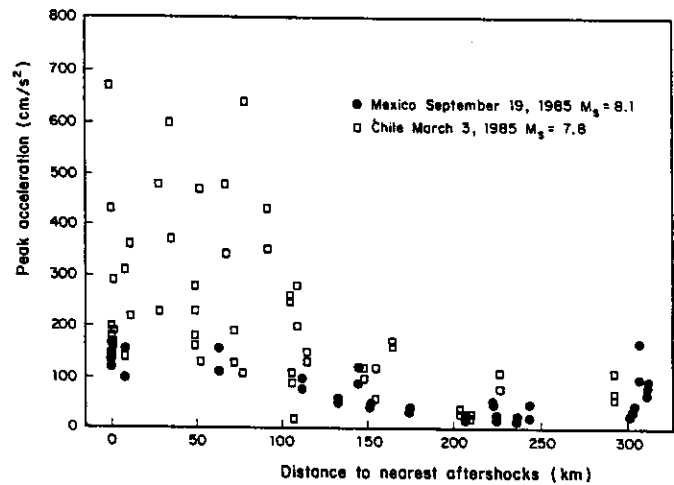
Fig 13. Peak ground accelerations as a function of distance for the 1985 Mexico and Chile earthquakes (after Anderson et al, 1986)

This picture stands in contrast with the one of the Chilean earthquake of March 3 in the same year. This too was a subduction earthquake with magnitude comparable to that of the Michoacán event. In Chile the peak accelerations in the epicentral region were two to three times greater than in Mexico and the decline with distance was steady and considerably more pronounced (Anderson et al, 1986), as may be seen in fig 13.

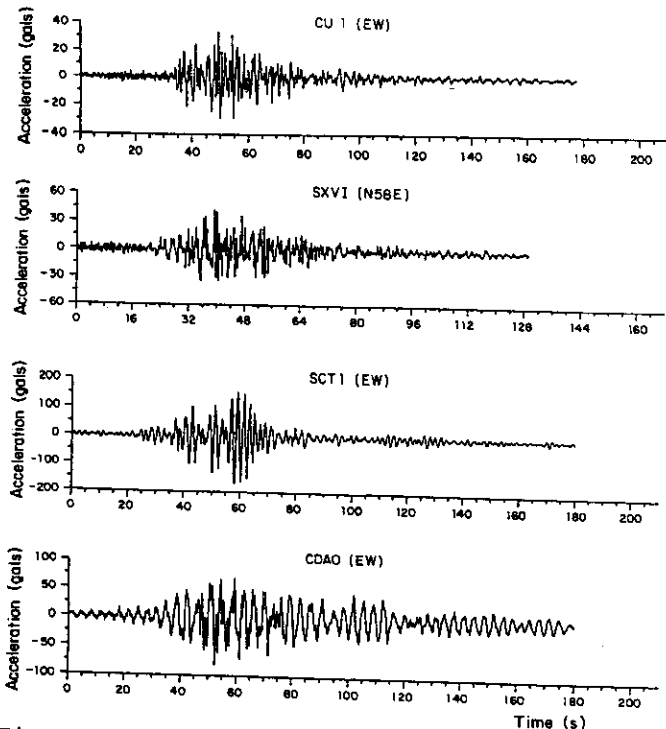
Fig 14. E-W acceleration components recorded in Mexico City. CU lies on volcanic basalt, SXVI is in the transition zone, SCT and CDAO are located in the old lake bed

The E-W components of representative accelerograms of the Michoacán earthquake are depicted in fig 14.

prevail in the valley. The initial periods of the most vulnerable 7-15 story buildings must have been about 0.8-1.8 s, frankly shorter than the 2 s prevailing period in the area of maximum damage (figs 14 and 15), but must have lengthened appreciably as the amplitude of responses increased during the main earthquake.

not properly reproduced (fig 14). This type of ground motion was not apparent in the early damped response spectra because the mean responses were generally attained near the end of the strong-motion segment of the spectrum. For the same reason the coda is important for the design of structures whose strength does not appreciable degrade under repeated loading, but it can be decisive for brittle structures, such as those whose strength is conditioned by the strength of steel in compression, by that of unconfined concrete, unreinforced masonry and, in some cases, by reinforced masonry as well, or by bond between reinforcing bars and concrete. For such structures the information furnished by response spectra is insufficient, and hence so are the results of one-dimensional site-effect analyses.

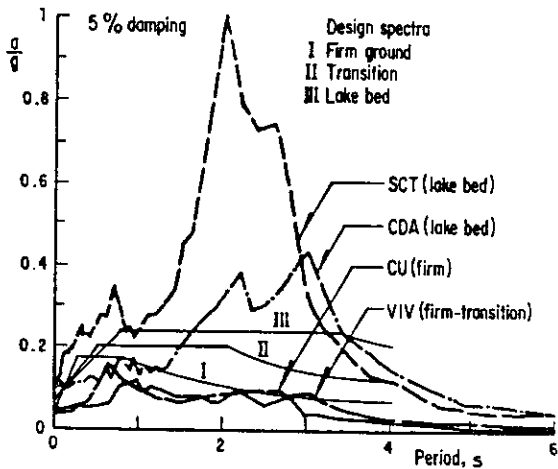
Fig 15. Normalized acceleration spectra for 5 % damping at several stations in the 1985 Mexico earthquake calculated from E-W components (after Meli and Ávila, 1989)

The amplifications, although still enormous, are not so pronounced when comparing response spectra for a finite damping ratio. Fig 15 displays the normalized acceleration response spectra with 5 percent damping for the E-W components of ground motion at several stations in the valley. The highest spectral ordinate found occurs at a period of 2.0 s in the EW

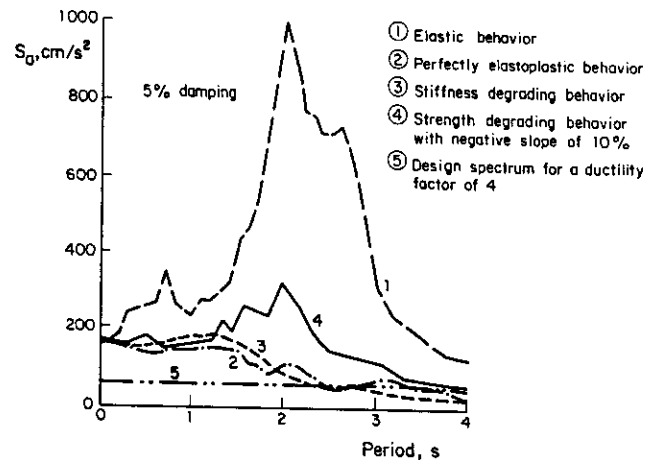
Fig 17. Inelastic acceleration spectra of the SCT-W record for a ductility factor of 4 (after Meli and Ávila, 1989)

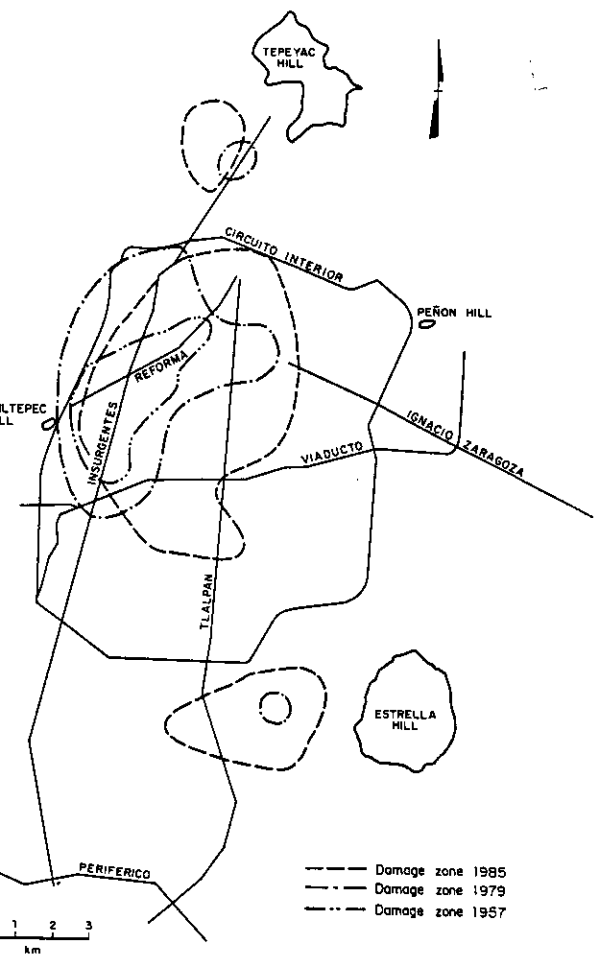
18. Damage zones in Mexico City for three earthquakes (after Iglesias et al, 1988)

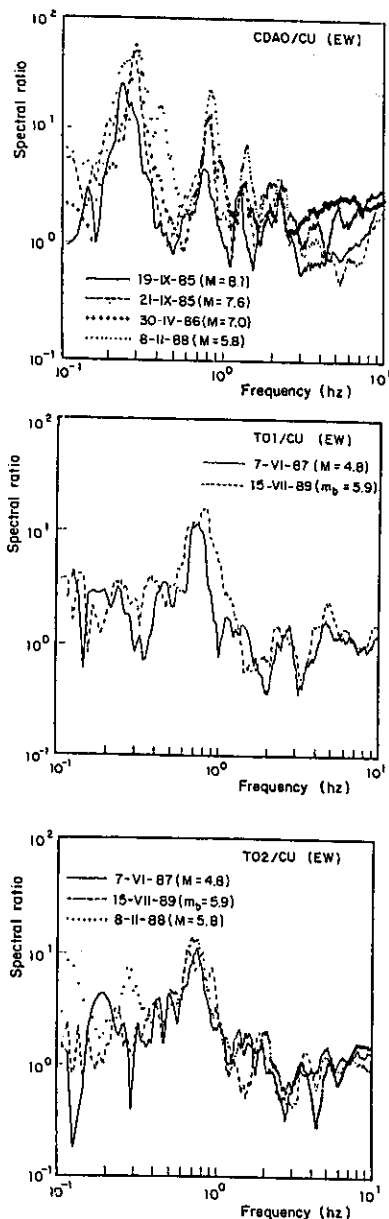
Fig 19. Transfer function of different stations with respect to a site on firm ground (CU), (after Singh et al, 1989a)

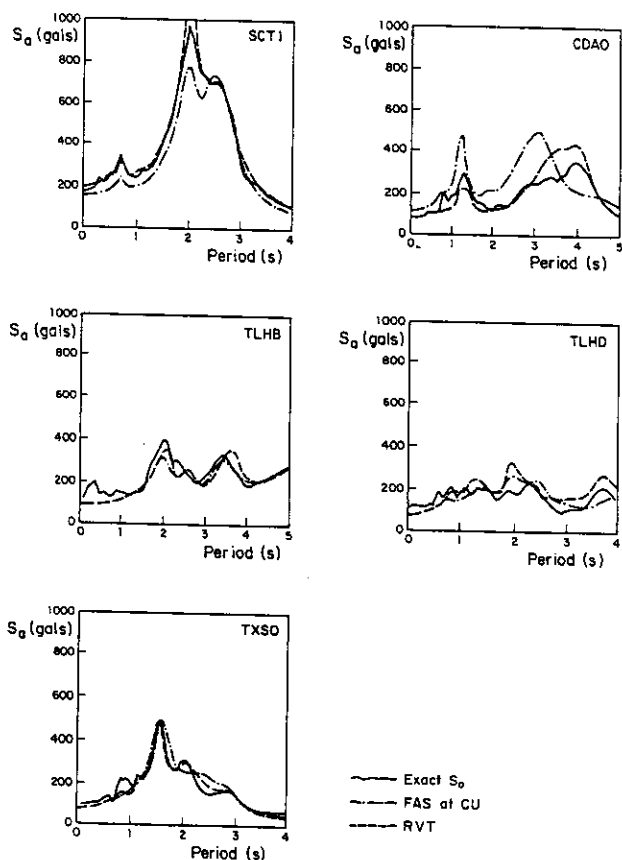
Fig 20. Comparison of exact S_a (continuous line) S_a computed from Fourier amplitude spectra at CU (dotted line) and from random vibration theory (dashed line) (after Ordaz et al, 1988)

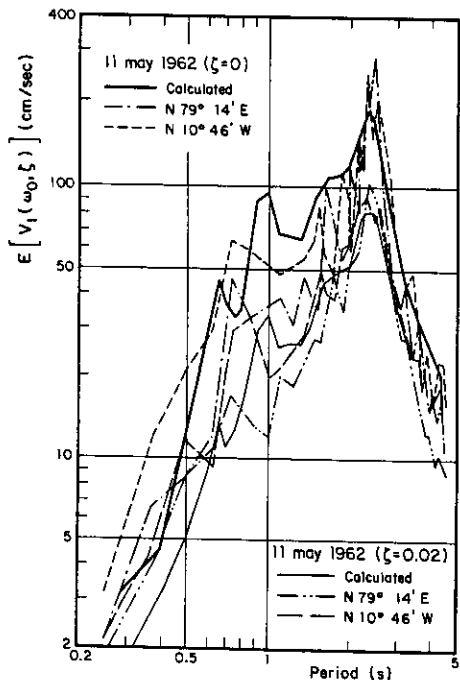
Fig. 21. Early attempts to predict ground motion in Mexico City (after Herrera et al, 1985)

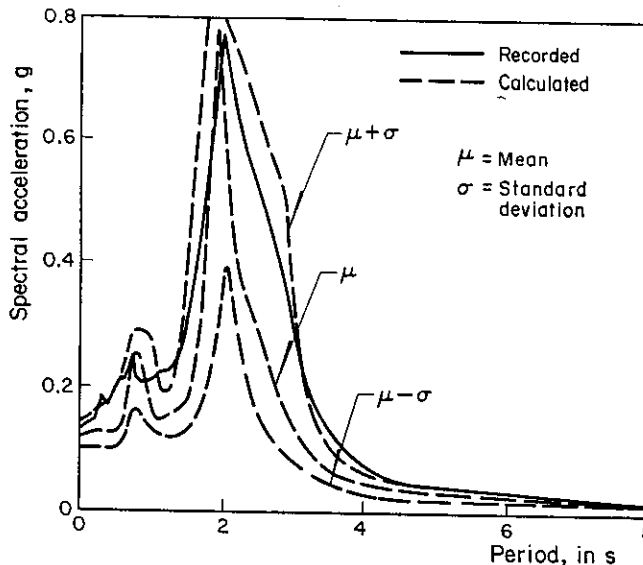
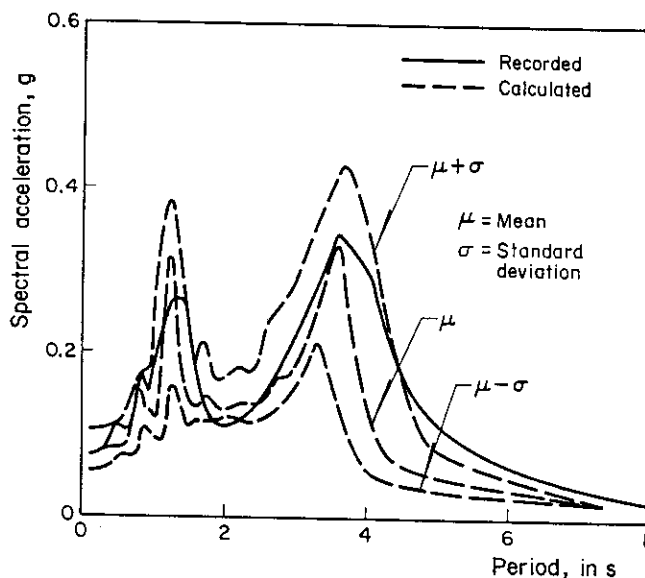
Fig 22. Calculated smoothed response spectra versus average spectra obtained from actual E-W acceleration records in 1985. Top: SCT; bottom: CDAO (after Romo et al, 1988)

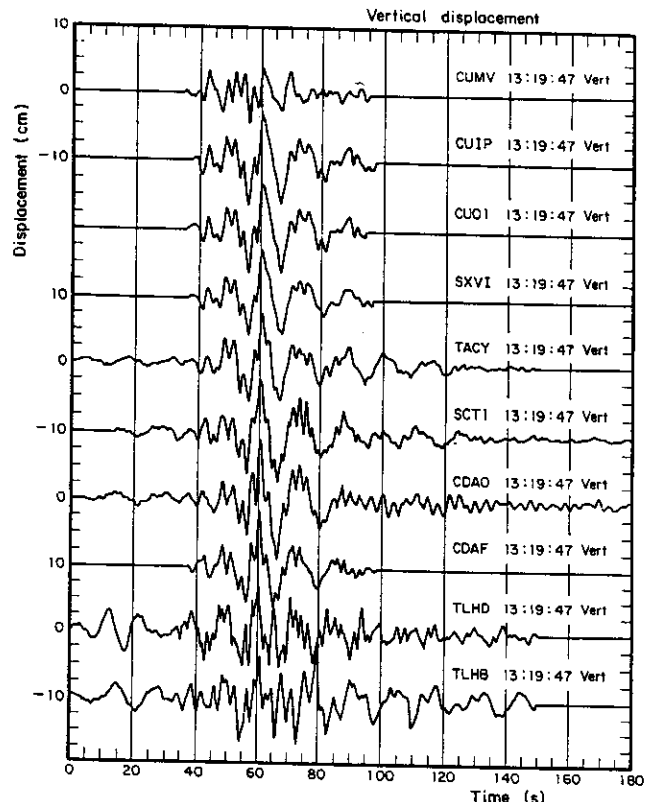
Fig 23. Vertical displacements in Mexico City during the September 19, 1985. For location of sites see fig 1 (after Campillo et al, 1986)

For large earthquakes the double integration of the vertical accelerograms gives an interesting picture of the histories of vertical ground movements. Their shapes as functions of time are appropriately shifted very little from seismic station to seismic station (fig 23). The maximum vertical displacement was about 5 cm in 1985. The dominant horizontal wavespeed within the valley of Mexico was close to 1.5 km/s (Campillo et al,

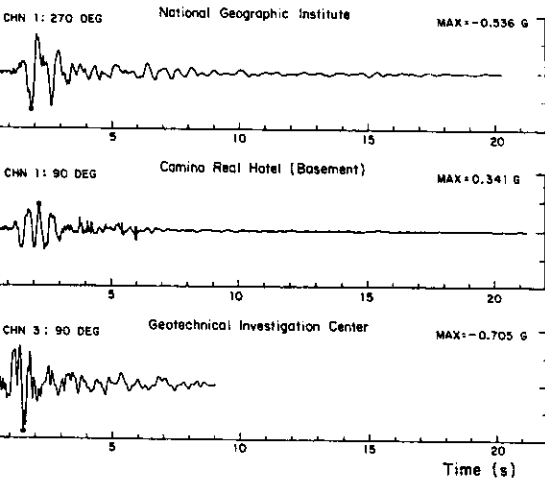
Accelerations recorded during the 1987 San Salvador earthquake (after Shakal et al,

... after the main shock indicates that the ... of October 10, 1986 originated along ... subparallel to the Central American ... chain (White et al, 1987). According to ... et al (1989), this earthquake had a ... lateral strike-slip mechanism with a ... ruptured plane oriented N32°E. They ... contend that the reported magnitude of $M = ...$ is not consistent with the severity of ... Eleven strong motion accelerographs ... at epicentral distances ranging from 1 ... m had been installed at the time of the ... quake. Ground level accelerations recorded ... of them varied between 0.32 and 0.72 g. ... tentative accelerograms and response spec- ... are shown in Figs 24 and 25 (Shakal et al,

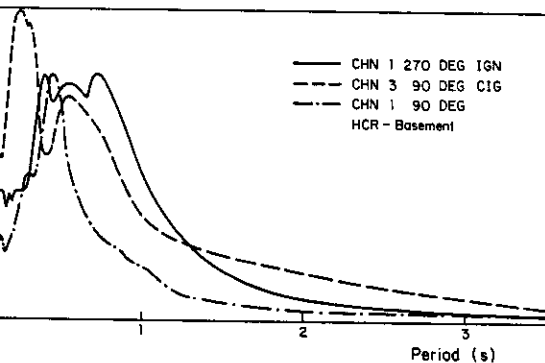
Response spectra for the 1987 San Salvador earthquake (data taken from Shakal et al, 1987)

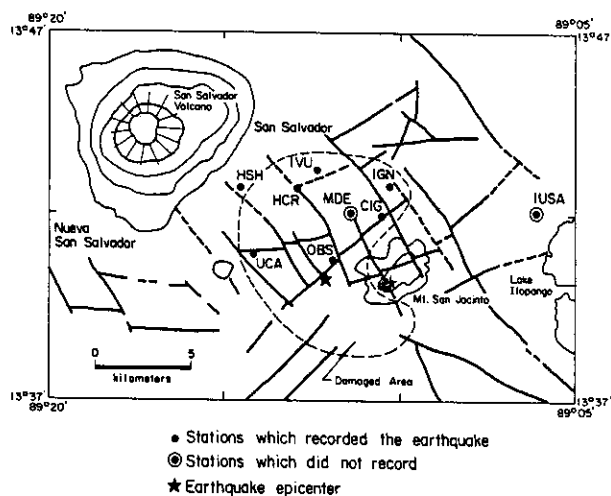
Fig 26. Damage zone, epicenter and strong motion recording stations for the San Salvador 1987 earthquake (after Shakal et al, 1987)

Most of the damage concentrated in a relatively flat plateau between the San Salvador Volcano and Mt San Jacinto (fig 26). Local geotechnical and geologic conditions played an important role in the amount and distribution of damage. Foremost among these are the conditions of the two tuff units described above. In San Salvador, landslides were frequent in slopes along steep natural ravines cutting the tuffs. At the time of the slides, many dwellings constructed near the edges of the gorges were completely destroyed; others, at the base of the slopes were also damaged. In modified slopes, some cases of failures in earth retaining structures too were reported. Landslides also disrupted highways along cuts made mainly into the tierra blanca unit. Soil falls and slides, slumps and rapid soil flows were noted over an area in and around San Salvador of at least 200 km². No liquefaction was detected in San Salvador—the tuff units are partly saturated or dry during most of the year—nor along Lake Ilopango where

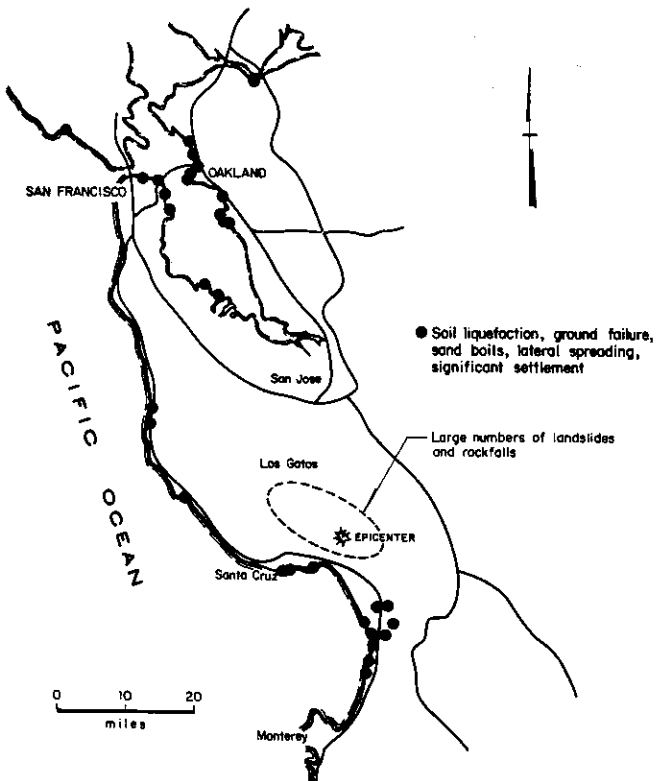
Fig 27. Epicenter and damage map for the Loma Prieta earthquake (data taken from USGS, 1989)

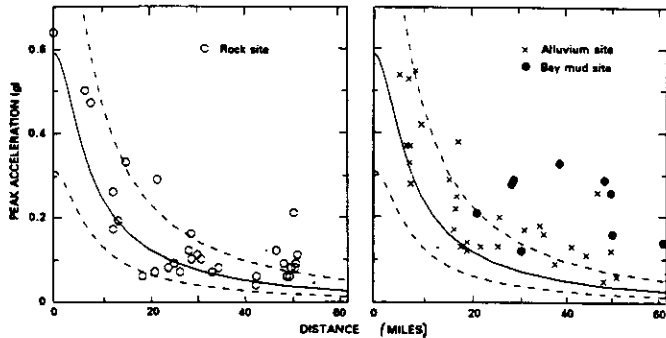
Fig 28. Maximum ground acceleration as a function of epicentral distance. Loma Prieta earthquake (after USGS, 1989)

An extensive net of accelerographs yielded instrumental records of strong ground motion at more than 100 sites within 190 km from the epicenter. Recorded maximum ground accelerations on rock sites were compared with those predicted, as a function of epicentral distance, using Joyner and Boore's attenuation law (USGS, 1989), as shown in fig 28. Despite the observed scatter, predicted values tend to agree with observations even though a slight tendency for underestimating them could also be argued for. Maximum accelerations on young alluvium sites and on bay mud show the effect of local

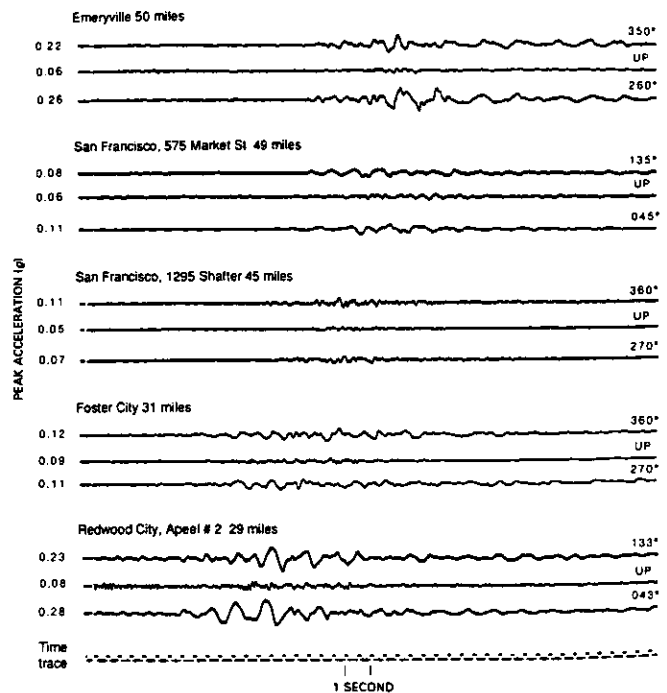
Fig 29. Accelerograms showing the effect of local soil conditions. The 1295 Shafter site lies on bedrock and the other ones on unconsolidated deposits (after USGS, 1989)

amplification. Predicted values on these sites are, in general, considerably lower than the actual ones. A clear illustration of the influence of local site conditions during this earthquake is provided by the acceleration time histories recorded at one site on bedrock and at four sites underlain by unconsolidated deposits (fig 29). Deep clay deposits surrounding the San Francisco Bay amplified ground motions considerably. A preliminary assessment of amplification effects showed that in stiff soil sites maximum horizontal acceleration was about 0.1 g whereas in locations having deep clay deposits it was 2.5 times larger (Seed et al,
